# Physicochemical Analysis of Groundwater sample of Cheeplata Village of Neemkathana Block of Sikar India

### Assessment of groundwater of Cheeplata village in Neemkathana block

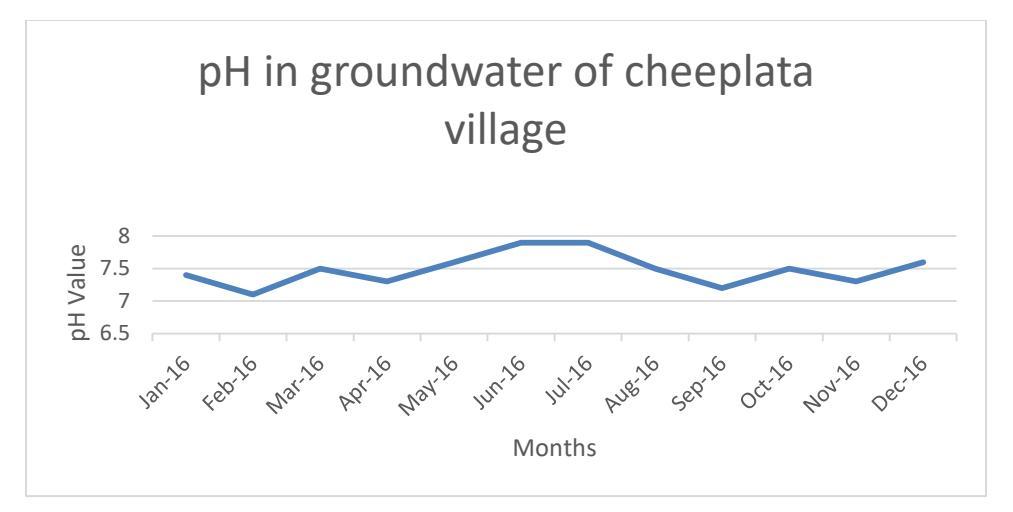
Figure 1: pH of groundwater in Cheeplata village of Neemkathana block

Figure 1 shows that the pH of the groundwater of Cheeplata village found within (BIS IS 10500: 2012) acceptable limit of 6.5 – 8.5 for the assessment year from Jan-2016 to Dec-2016. A minimum of 7.1 was observed in the month of Feb-2016, and a maximum of 7.9 was observed in the month of July 2016.

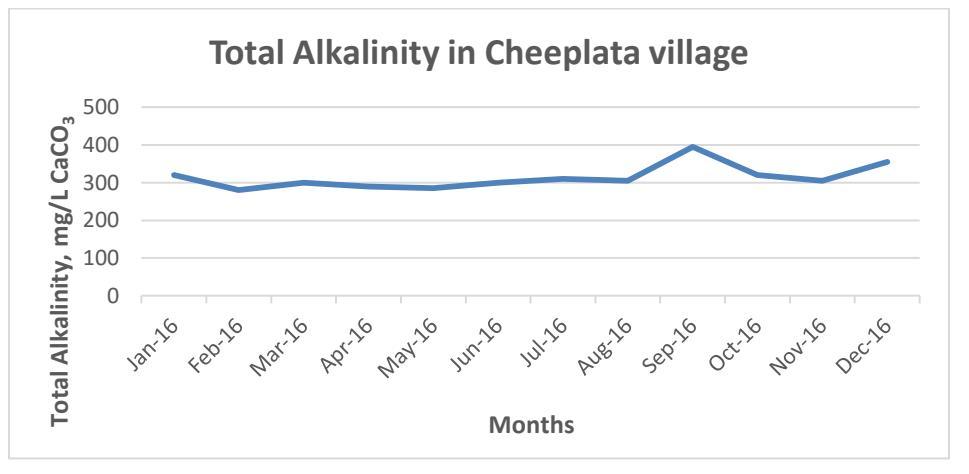
Figure 2: Total alkalinity in groundwater of Cheeplata village in Neemkathana block

Figure 2 shows that the total alkalinity for the groundwater of Cheeplata village was found beyond

the BIS (IS 10500: 2012) acceptable limit of 200 mg/L, but all the results are within the permissible limit of 600 mg/L, the results of the test indicate that the value is maximum 395 mg/L in the month of Sept-2016 while minimum 280 mg/L in the month of Feb- 2016.

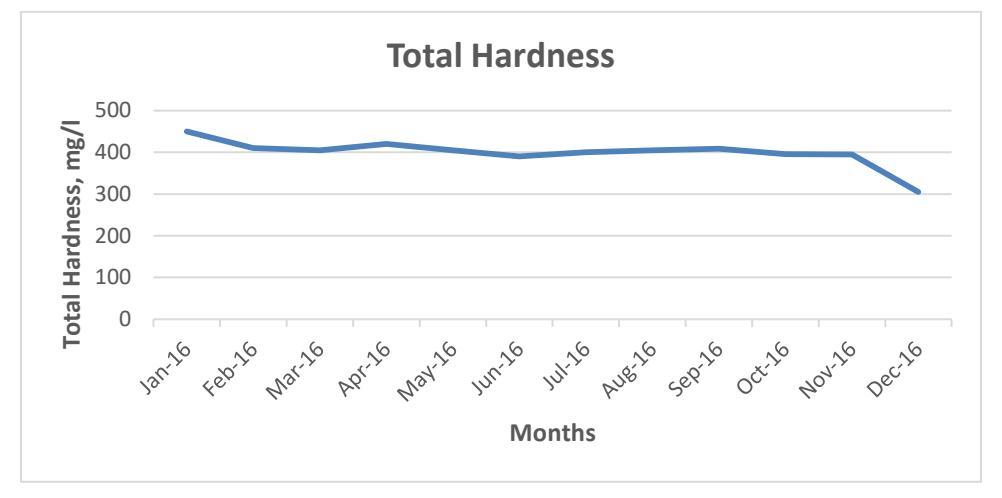
Figure 3 shows the assessment of parameter total hardness for the assessment period and the results state that the maximum total hardness of 450 mg/L was found in the month of Jan- 2016 and the minimum total hardness of 305 mg/L is observed in the month of Dec- 2016.

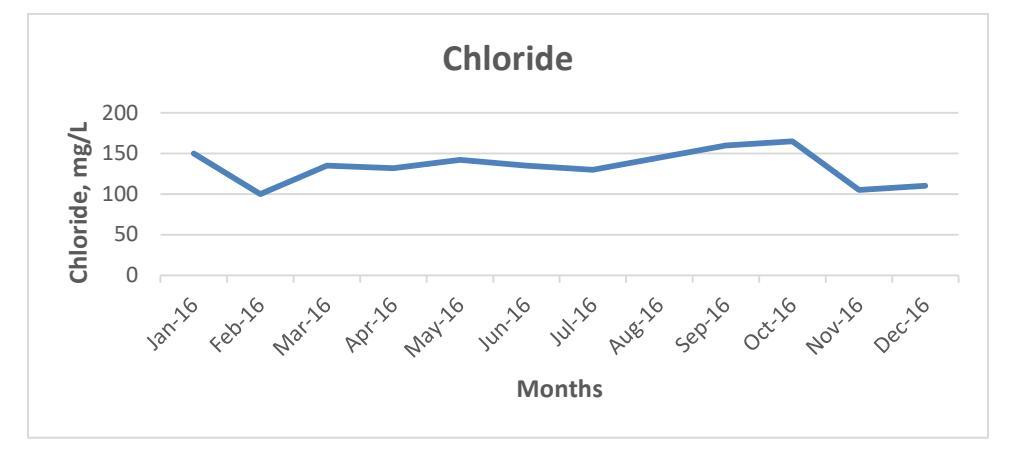
Figure 4: Chloride in groundwater of Cheeplata village in Neemkathana block

Figure 4 shows that maximum chloride 165 mg/L found in the month of Oct-2016 and the minimum chloride conentration100 mg/L is observed in the month of Feb-2016. The chloride concentration of groundwater in the Cheeplata village observed within the BIS (IS 10500: 2012) acceptable limit of 250 mg/L.

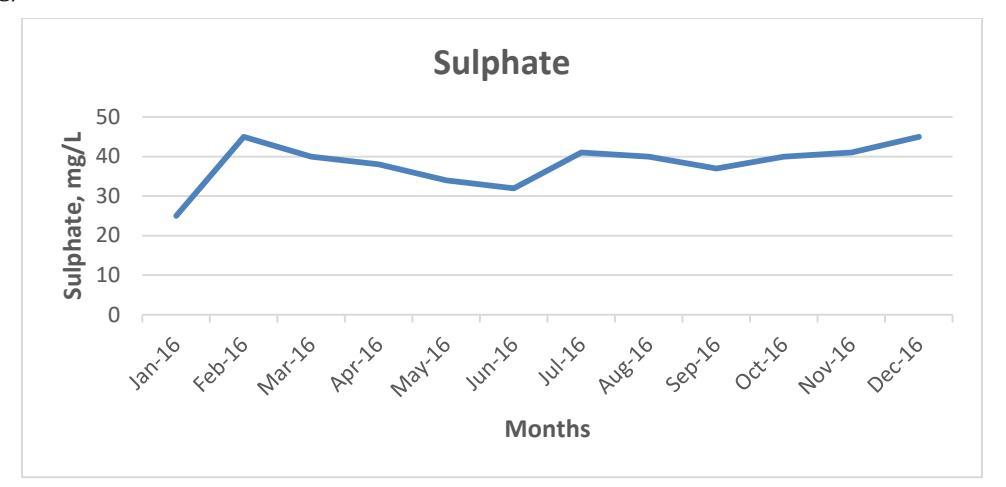
Figure 5: Sulphate in water of Cheeplata village of Neemkathana block

Figure 5 shows that the maximum sulphate 45 mg/L found in the month of Feb-2016 and the minimum 25 mg/L sulphate is found in the month of Jan- 2016. The sulphate concentration in groundwater of Cheeplata village is observed higher than the BIS (IS 10500: 2012) acceptable limit of 200 mg/L.

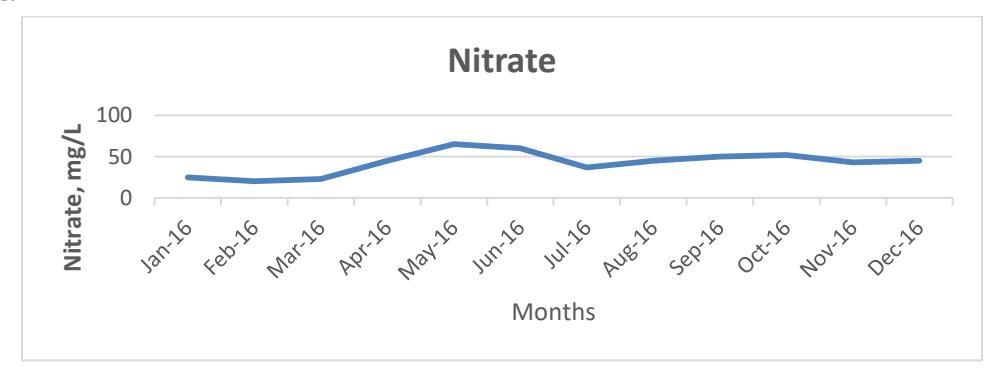
Figure 6: Nitrate in groundwater of CHEEPLATA village in Neemkathana block

Figure 6 shows that maximum nitrate 65 mg/L found in the month of May 2016 and the minimum 20 mg/L nitrate is found in the month of Feb-2016. Test result reveals that the nitrate concentration of groundwater in the Cheeplata village observed are within the BIS (IS 10500: 2012) acceptable limit of 45 mg/L.

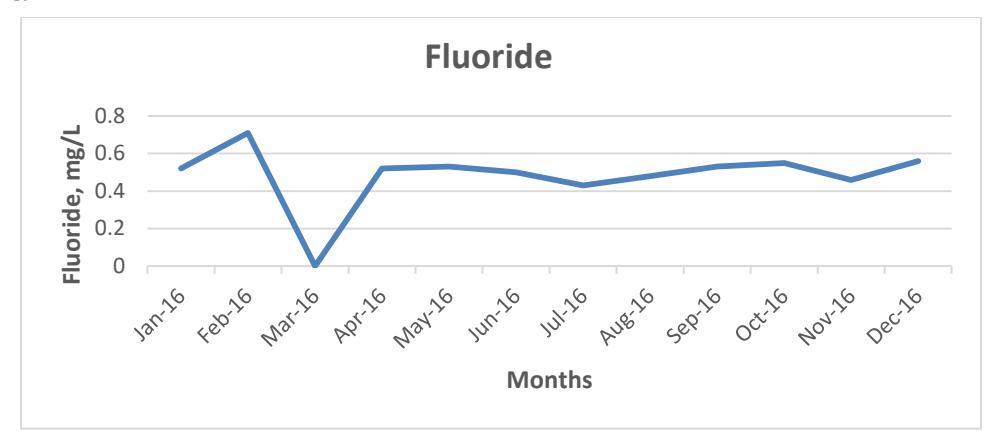
Figure 7: Fluoride in groundwater of Cheeplata village of Neemkathana block

Figure 7 shows that the fluoride concentration variation for the assessment period Aug-20 to Jul-21 is 0.43 mg/L -0.71mg/L. The maximum fluoride 0.71 mg/L found in the month of Feb-2016 and the minimum fluoride 0.43 mg/L is found in the month of July 2016.

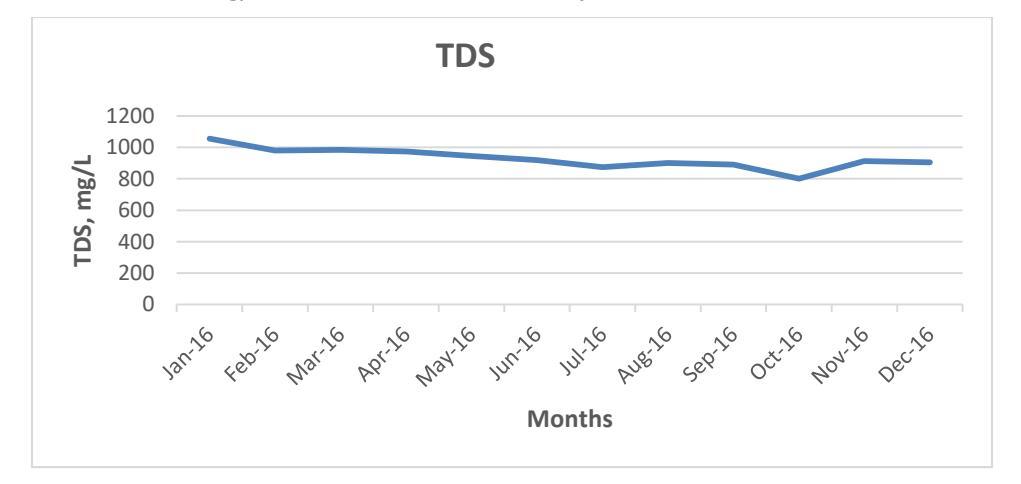
Figure 8: TDS in groundwater of Cheeplata village of Neemkathana block

Figure 8 shows that the Total Dissolved Solids (TDS) variation for the assessment period Jan 2016 to Dec-2016 is 800 mg/L-1055 mg/L. The maximum TDS 1055 mg/L found in the month of Jan-2016 and the minimum TDS 800 mg/L is found in the month of Oct-2016. Test result reveals that the total dissolved solid (TDS) in groundwater of the Cheeplata village observed higher than the BIS (IS 10500: 2012) acceptable limit of 500 mg/L.
